Use of Compaction Grouting as Ground Improvement Technique in Compressible Solid Waste Landfill

G. Tsitsas (corresponding author)

GT Ground Engineering & Construction Services, Bucharest, Romania

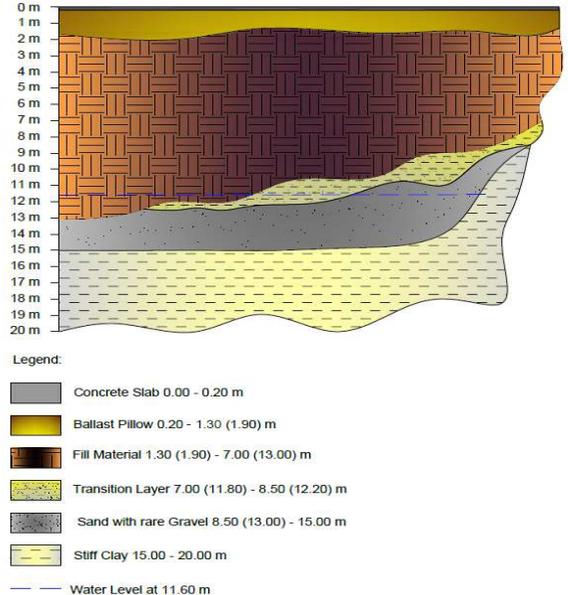
Figure 2. Soil profile at the site under consideration.

Based on a detailed evaluation of the available soil borings, the soil conditions in the area of the project consist of layered soils, including a layer of non-homogeneous fill of varying thickness followed by layers of sand, with some gravel and stiff clay. The groundwater table was measured at 11.60 m below ground level. Figure 1 presents drilling samples from different depths and locations underneath the structure; hence, providing a qualitative display of the subsurface conditions.

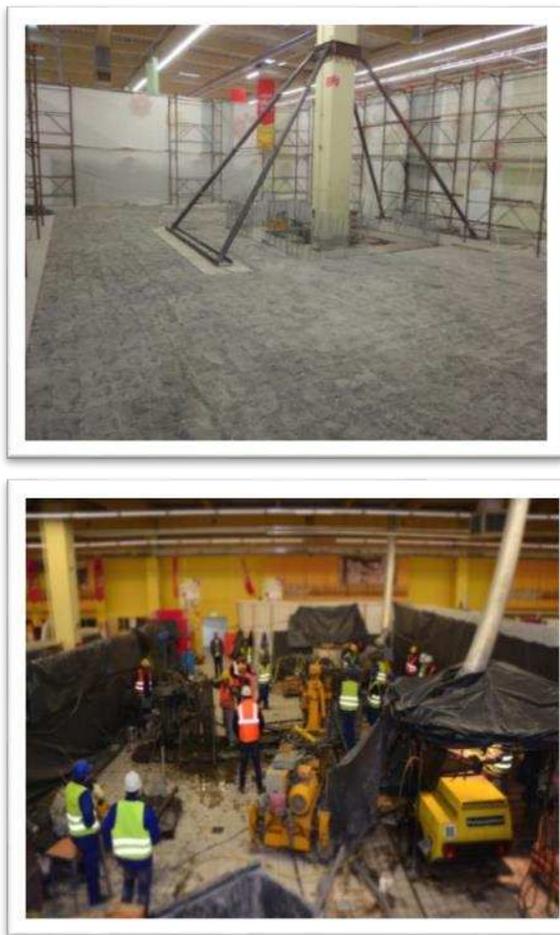
Figure 3. Views of the injection works inside the structure.

The objective of the performed works was to stop excessive settlements, which were ongoing for several years and varied in some areas between 5 and 24 cm. Works were scheduled in night shifts, in order to minimize disturbance, given that the commercial activity could not cease during the project. The columns' injection was generally performed on a primary and secondary grid to achieve optimum confinement. Underneath the concrete slab of the structure, grout columns were injected at a centre-to-centre distance of 2 meters, whereas around the footings, 8 columns were injected in total, 4 vertical and 4 inclined by 6 degrees. The total volume of the injected mortar exceeded 5,000 m³ and the minimum and maximum mortar injected in one column ranged between 3 m³ and 12 m³ respectively, which indicates a highly non-uniform soil. In Figure 3 typical views of the performed works are presented.

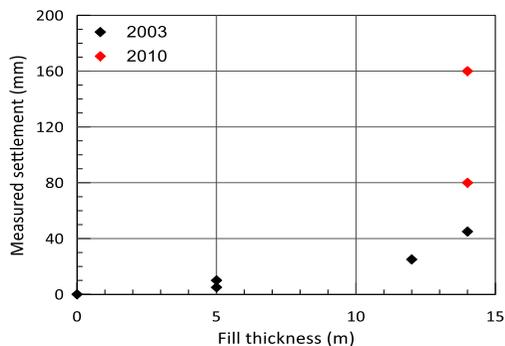
Figure 4. Measured settlements in 2003 and 2010, as a function of the fill thickness.

Monitoring of the settlements started in 2003 (immediately after construction) for 60 columns of the structure, making up almost 25 percent of the total number of columns of the building. Significant settlements were measured already from the first year, which were analogous to the thickness of the fill material and reached up to 45 mm in the areas of the maximum thickness of the compressible layer. Then in 2010, settlements had accumulated to 160 mm in the same location with 0.5 – 0.8 mm settlement being added per month at the critical columns. This was a clear indication of the emergency of the situation. The above measurements from 2003 and 2010 are shown in Figure 4, as a function of the fill thickness, from where a direct link between the thickness of the fill and the magnitude of the settlements is observed. Namely, at the locations where the thickness of the fill material was 14 m, the settlement increased by a scale of 2 to 4 times reaching the level of 80 to 160 mm.

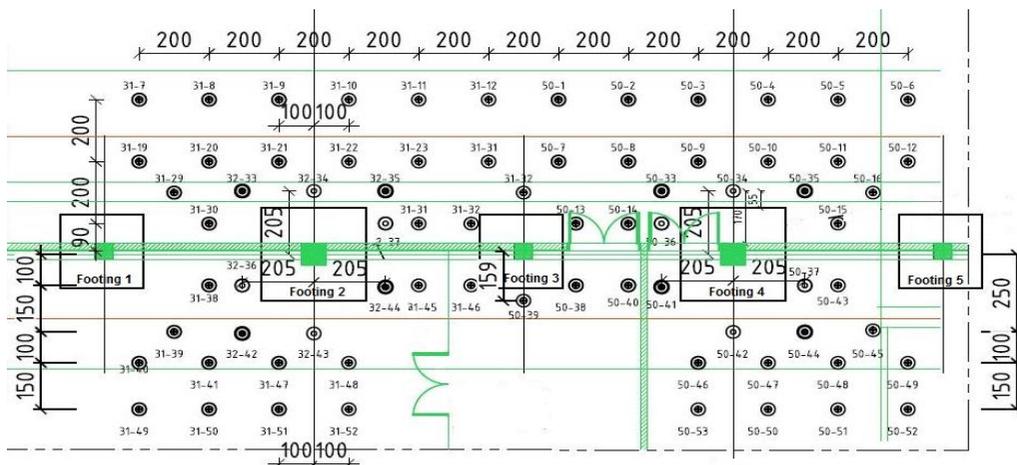
Figure 5. Plan view of the treated area in 2017.

In the present paper, the data from works performed during the last intervention that took place in 2017, are used. The particular intervention covered an area of 361 m², where smaller settlements accumulated. In total 74 CG columns were injected for the stabilisation of 5 spread footings (Figure 5).

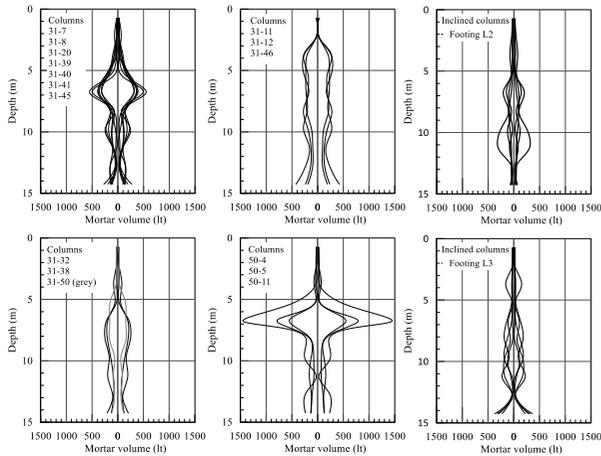
Figure 6. Mortar volume distribution with depth from selected locations from the treated area.

Figure 6 presents the distribution of mortar volume with depth from various locations of the treated area. These are grouped based on their shape and the amount of mortar used, in order to

obtain a better understanding of the nature and the response of the fill material to CG. Based on this figure, the highly non-uniform nature of the fill material becomes evident, as the used mortar volume presents a great variation between 3 and 12 meters. In addition, there is a direct influence of the soil layering on the column shape. Namely, in most cases the cross section of the column presents a significant bulging between 3 to 12 meters, implying the presence of a soft layer and in the sequel the cross section is reduced again, as compaction grouting progresses to the stiffer soil layers. This picture is also consistent with what is described in ASCE guidelines [1] and Figure 7. In the top 3 meters most of the column cross sections are rather narrow, implying the injection of low mortar volumes. This is expected, as due to the low overburden stress, the applied injection pressures need to be kept at low levels, to avoid damaging the superstructure. Based on the information from the entire database of the column logs (74 columns), it is estimated that the vertical columns absorbed from 0.79 to 3.94 m³ of solid grout, giving an average of 1.43 m³ with a standard deviation of 0.48. The inclined columns exhibited a higher consistency in terms of the absorbed volumes, ranging from 1.23 to 2.39 m³, with an average equal to 1.87 m³ and standard deviation of 0.40.

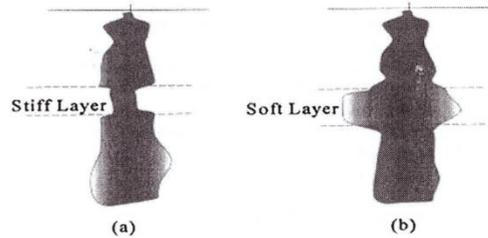
Figure 7. Effect of soil layering on column shape: (a) stiff layer leads to a reduced cross section (b) soft layer leads to enlargement (ASCE, 2010)

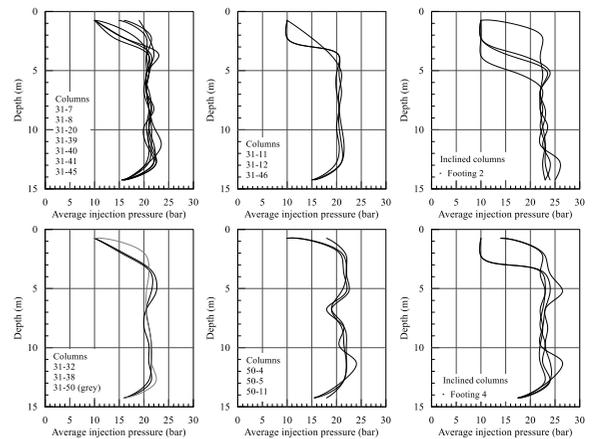
Figure 8. Average injection pressure with depth for selected columns of the treated area.

Figure 8 summarizes the distribution of the injection pressure with depth for selected locations of the treated area, including the inclined columns, which were constructed around foundations 2 and 4. It is observed that – on average and within the fill material (3 to 12 m) – the injection pressure remains constant and equal to 20 bar for all vertical columns. Regarding the inclined columns, a slightly higher injection pressure is recorded, which is equal to approximately 23 bar. Moreover, it is observed that in the top 3 meters, the injection pressures are significantly lower given the low overburden pressure.

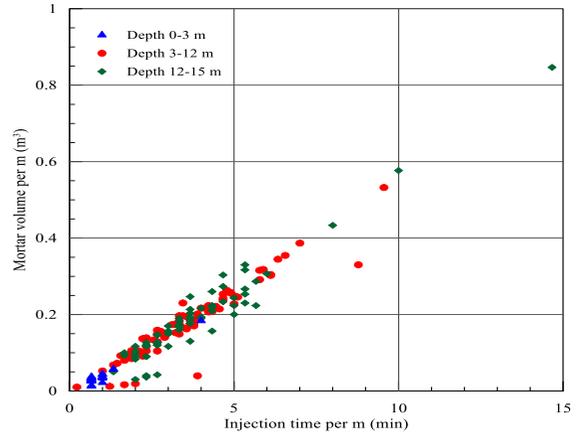
Figure 9. Normalized mortar volume against normalized injection time.

Figure 9 illustrates the correlation between the normalized mortar volume and the normalized total injection time for each distinct soil zone (as explained earlier) and each column. It is observed that for all three zones there is a linear correlation between the injection time and the mortar volume. The performed normalization here, essentially does not reveal what is observed in Figure 6, namely that in the middle zone there is the highest absorption of material, due to its compressibility.

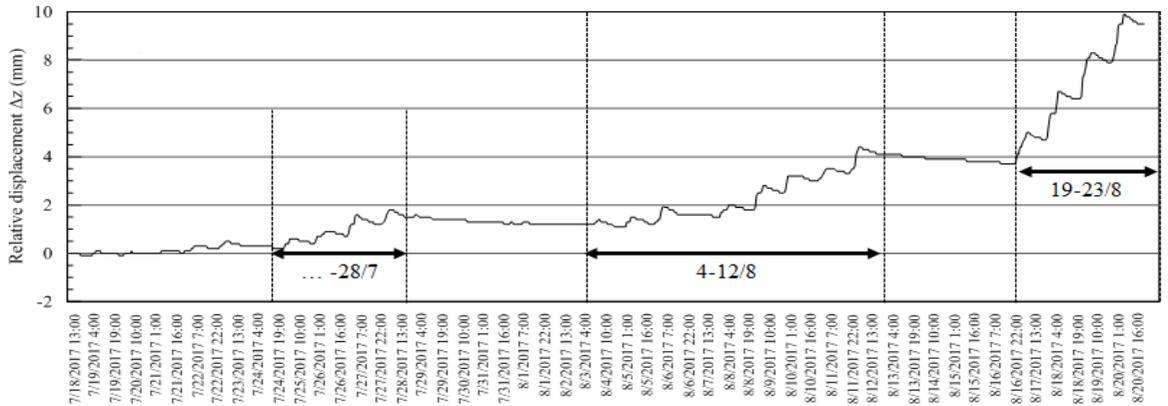
Figure 10. Relative vertical displacement footing 2.

Figure 10 shows the vertical relative displacements (Δz) of footing 2 as recorded by the monitoring instrumentation, performed by total stations and prisms. It is observed that three separate sections of uplift are recorded. Part I of the heave measures approximately 1.5 mm and occurs from the beginning of the works until July 28, 2017. During this time period, there were no ground improvement works taking place in the vicinity of footing 2, hence this is attributed to works performed in adjacent footings. The second part of uplift measures roughly 3 mm and was recorded from 4 – 12 of August of the same year. During that time, records from the columns logs show that columns 31-20, 31-21, 31-22, 31-23, 31-31, 31-48, 31-47, 31-41 and 31-40 were

injected. The final part of uplift, measures approximately 4 mm and was recorded between 19 – 23 August, when columns immediately neighboring the footing were injected, that is, 32-33, 32-34, 32-35, 32-36, 32-37, 32-42, 32-43 and 32-44. The conclusion was that the columns located closer to the footing have caused the greatest uplift. Horizontal relative displacements were insignificant.

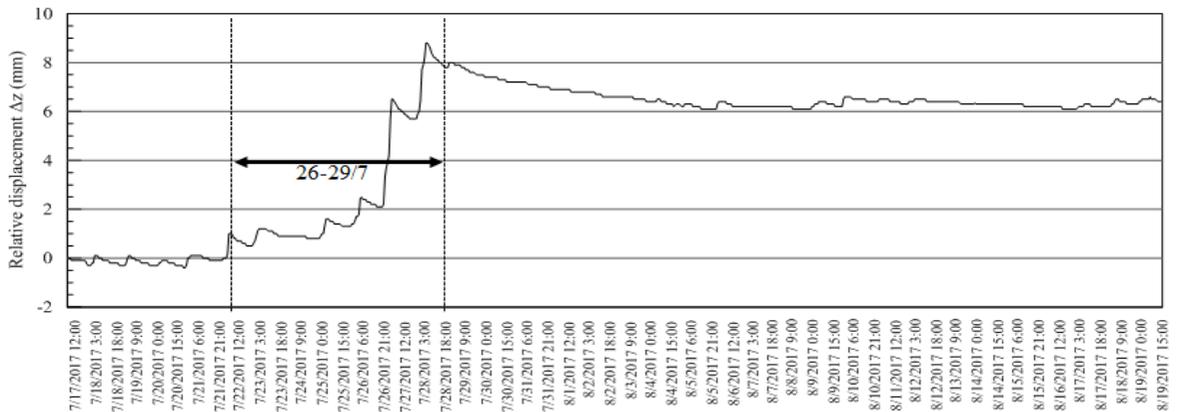
Figure 11. Relative vertical displacements for footing 4

Figure 11 summarizes the vertical relative displacements (Δz) of footing 4. It is observed that the recorded uplift reaches up to 6 mm between 26 - 29 of July. During that time, columns 50-33, 50-34, 50-35, 50-37, 50-42, 50-41, and 50-36, located in the vicinity of the footing were injected.
